MISCELLANEOUS PAPER S-69-27

# LANDING MAT OVERLAY ON DETERIORATED PAVEMENT

## BARE BASE SUPPORT

U. S. Army Engineer Waterways Experiment Station  
CORPS OF ENGINEERS  
Vicksburg, Mississippi

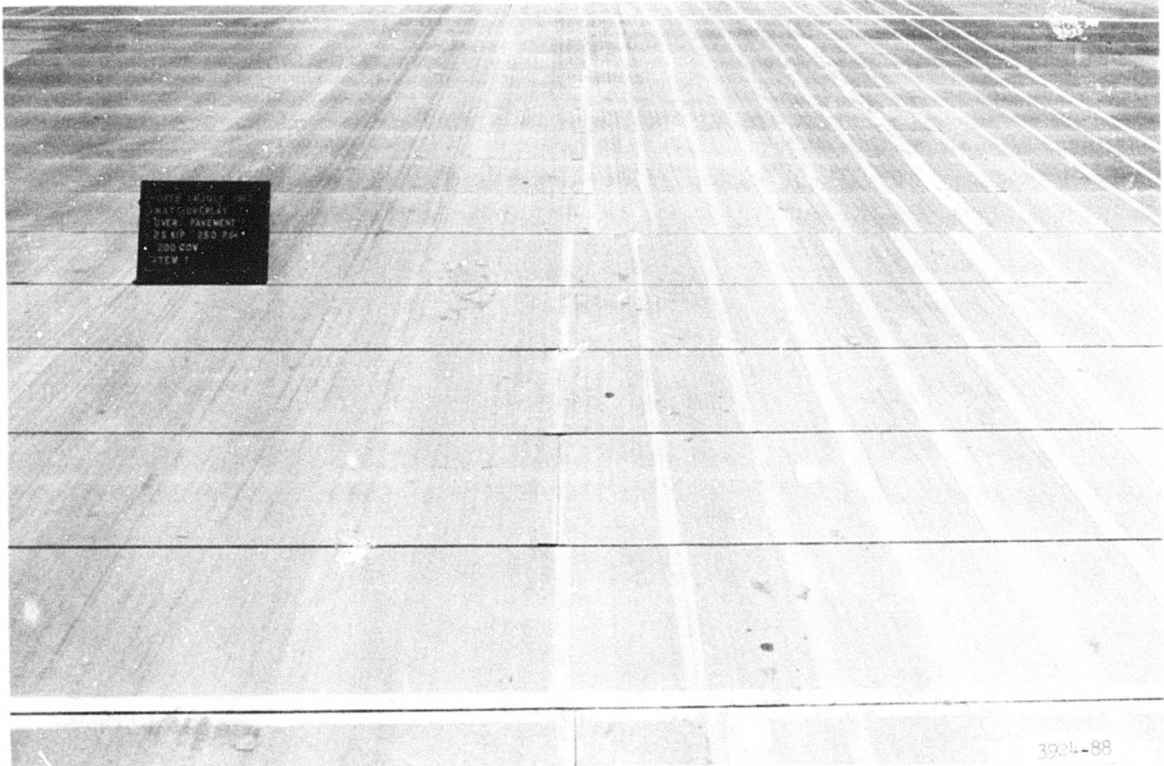
33. On 13 and 14 July, 120 coverages were applied to the test section (total 200). During this time, light rainfall in the test area resulted in soil pumping in items 3 and 4. The pumping consisted mainly of washing a small amount of fines from the clay gravel and was not considered particularly detrimental to these items. Items 1, 2, 5, and 6 all remained stable during this period with no apparent ill effects from the rainfall. General views of items 1 through 6 after 200 coverages are shown in photographs 17 through 22, respectively. As can be seen, the test section was quite serviceable at this time.

Photograph 17. Item 1 after 120 coverages applied during light rainfall  
(200 coverages total)

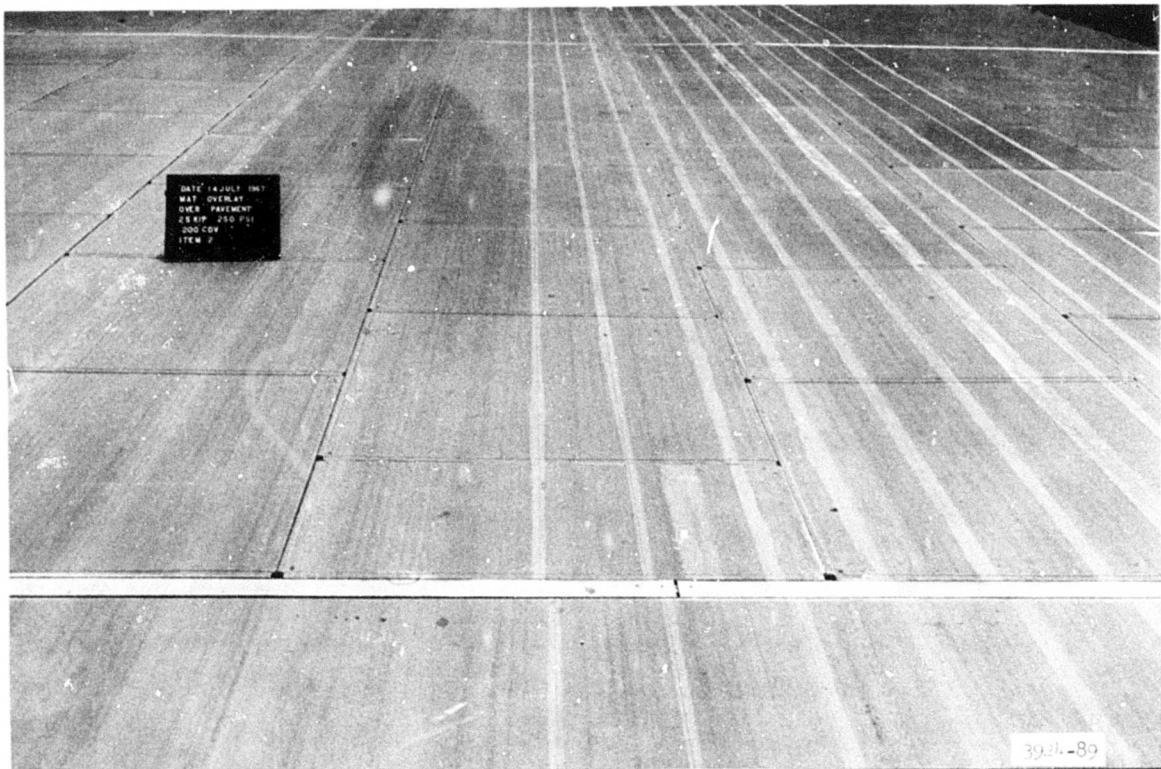
Photograph 18. Item 2 after 120 coverages applied during light rainfall  
(200 coverages total)

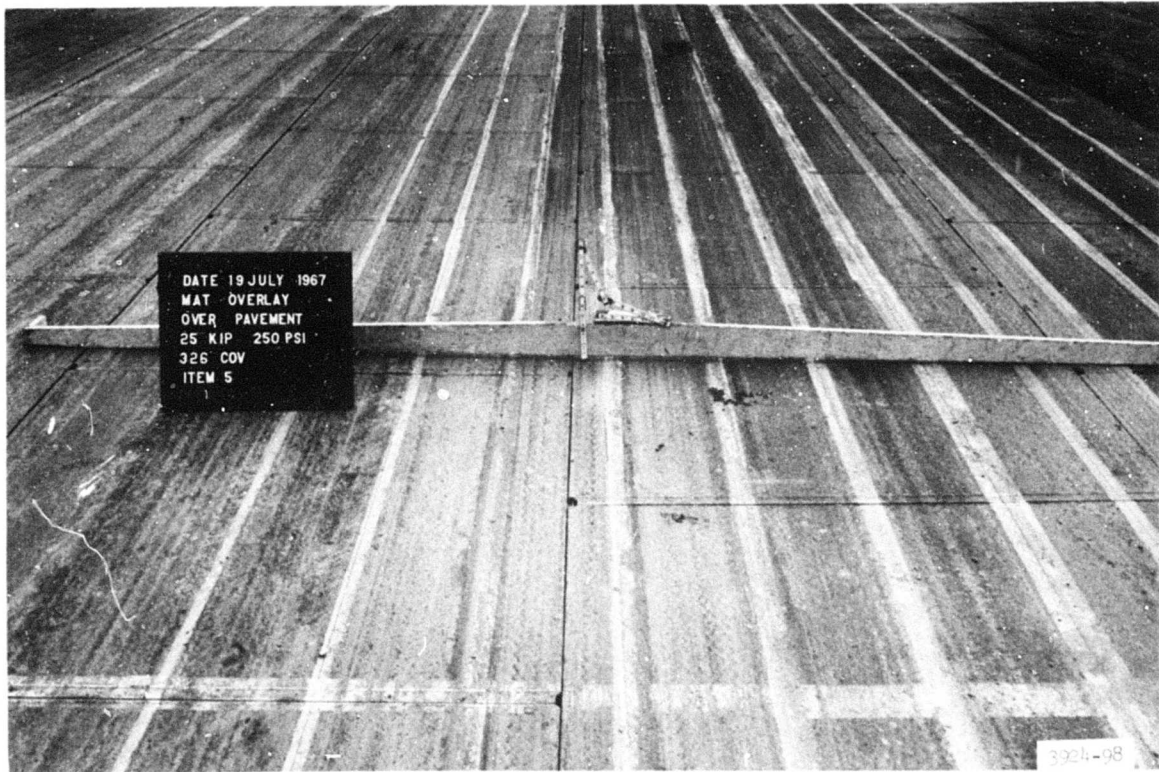
Photograph 27. Item 5 after 26 coverages applied during heavy rainfall  
(326 coverages total)

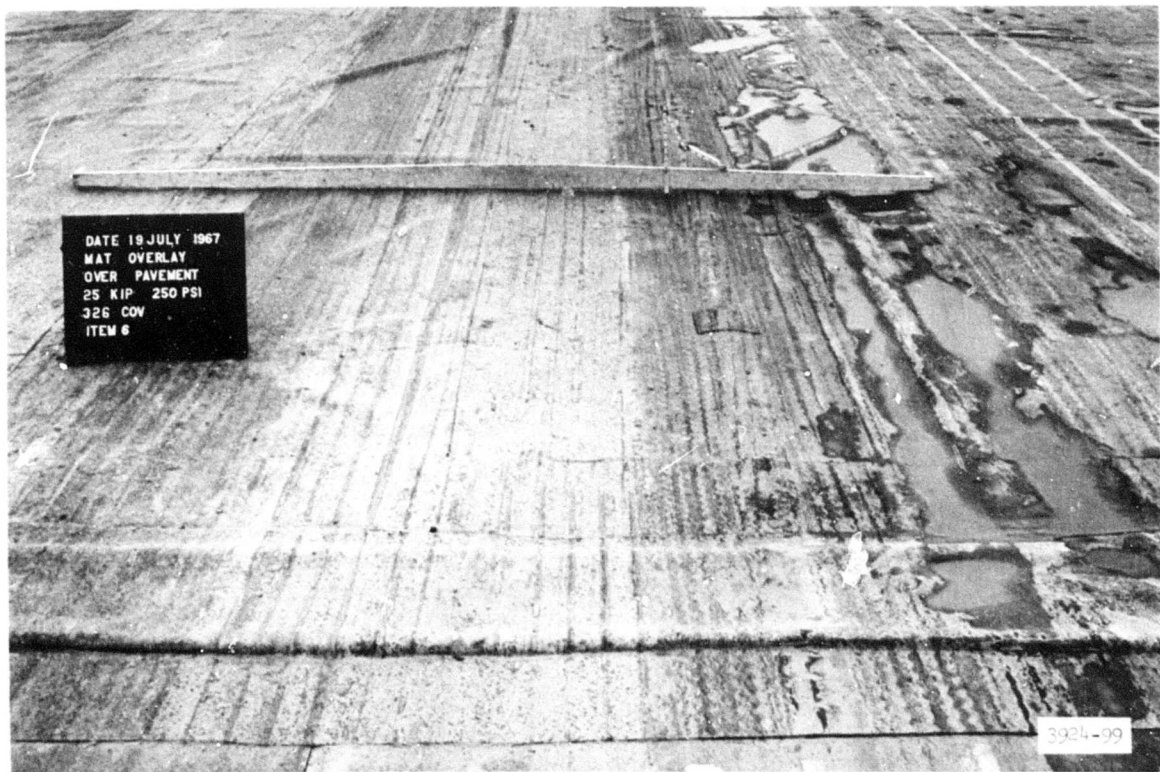
Photograph 28. Item 6 after 26 coverages applied during heavy rainfall  
(326 coverages total)

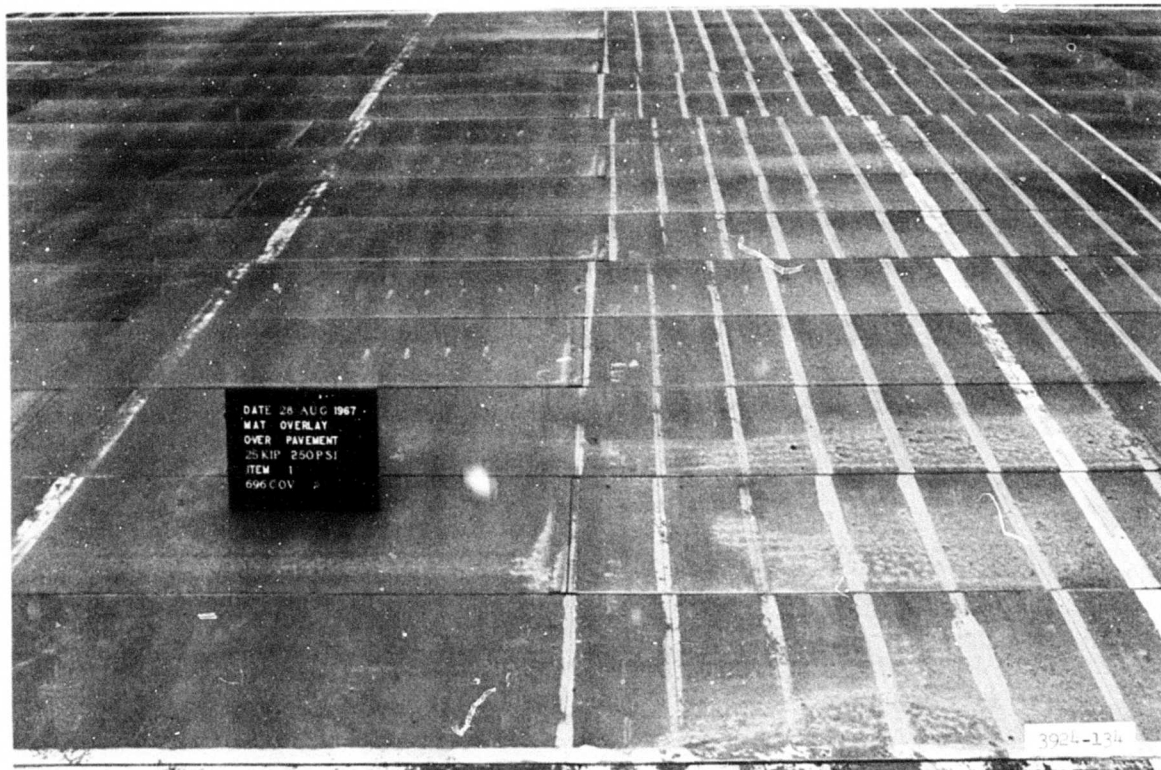
Photograph 37. Item 1 after 696 coverages

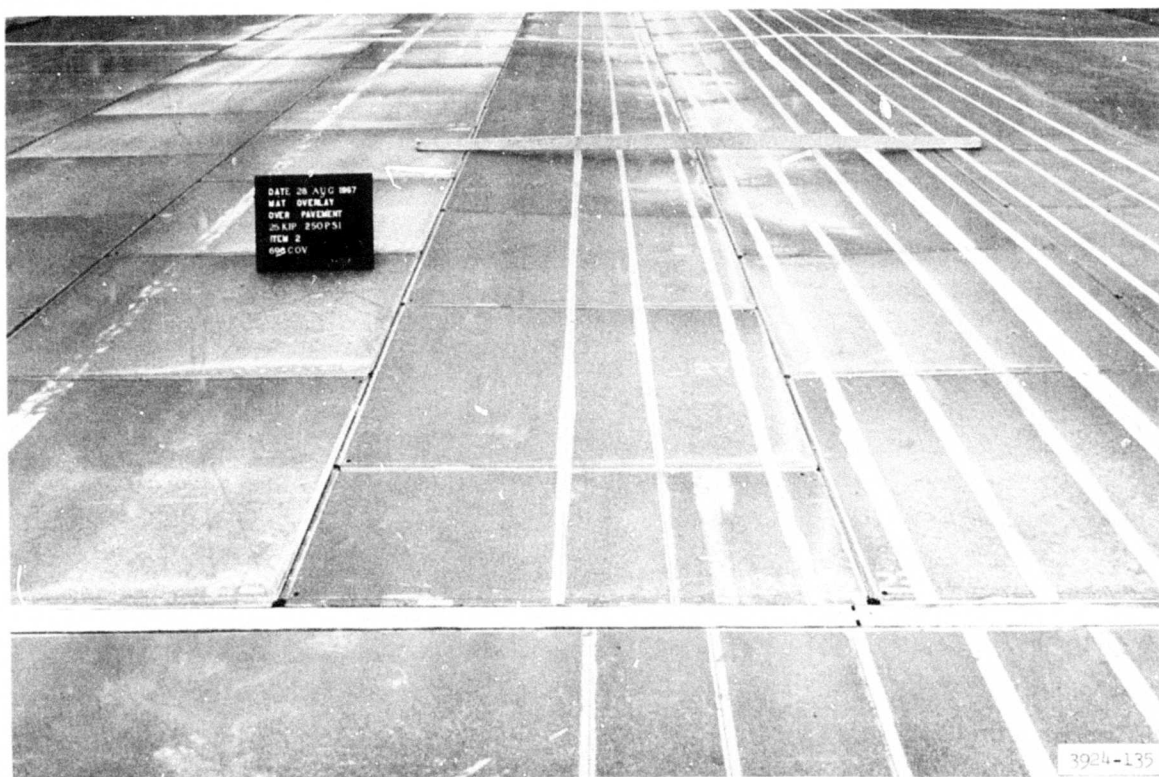
Photograph 38. Item 2 after 696 coverages

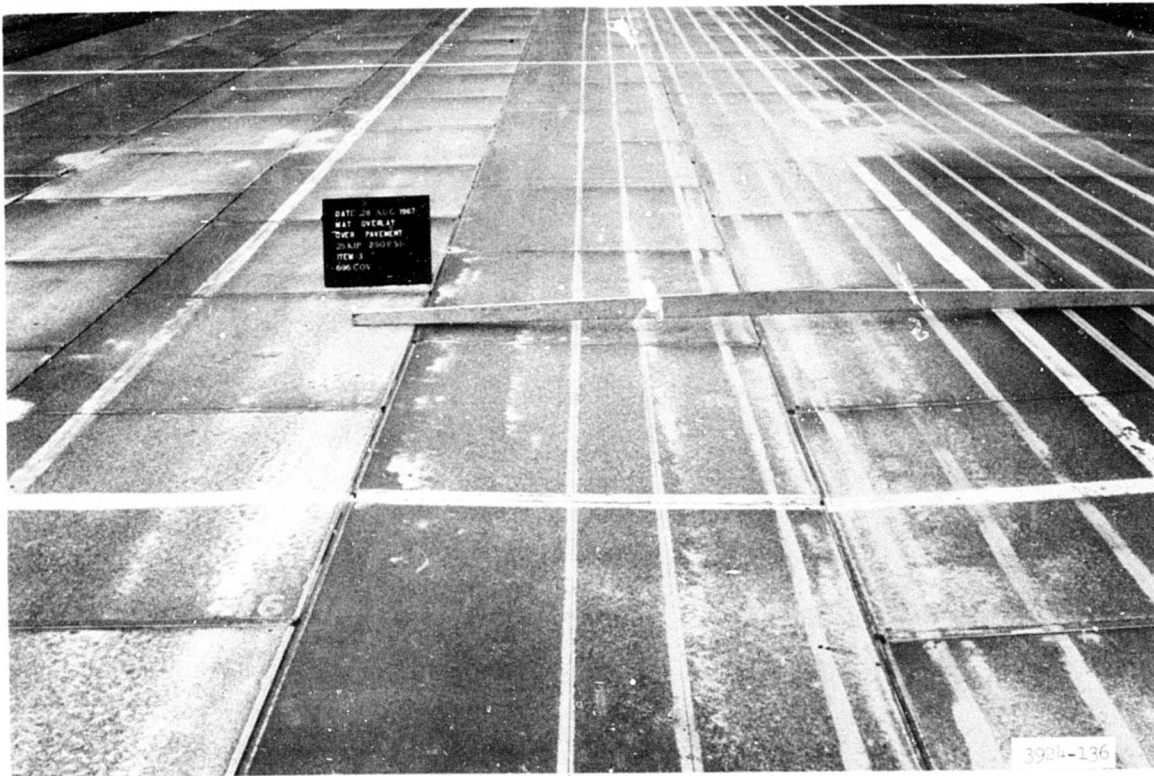
Photograph 39. Item 3 after 696 coverages

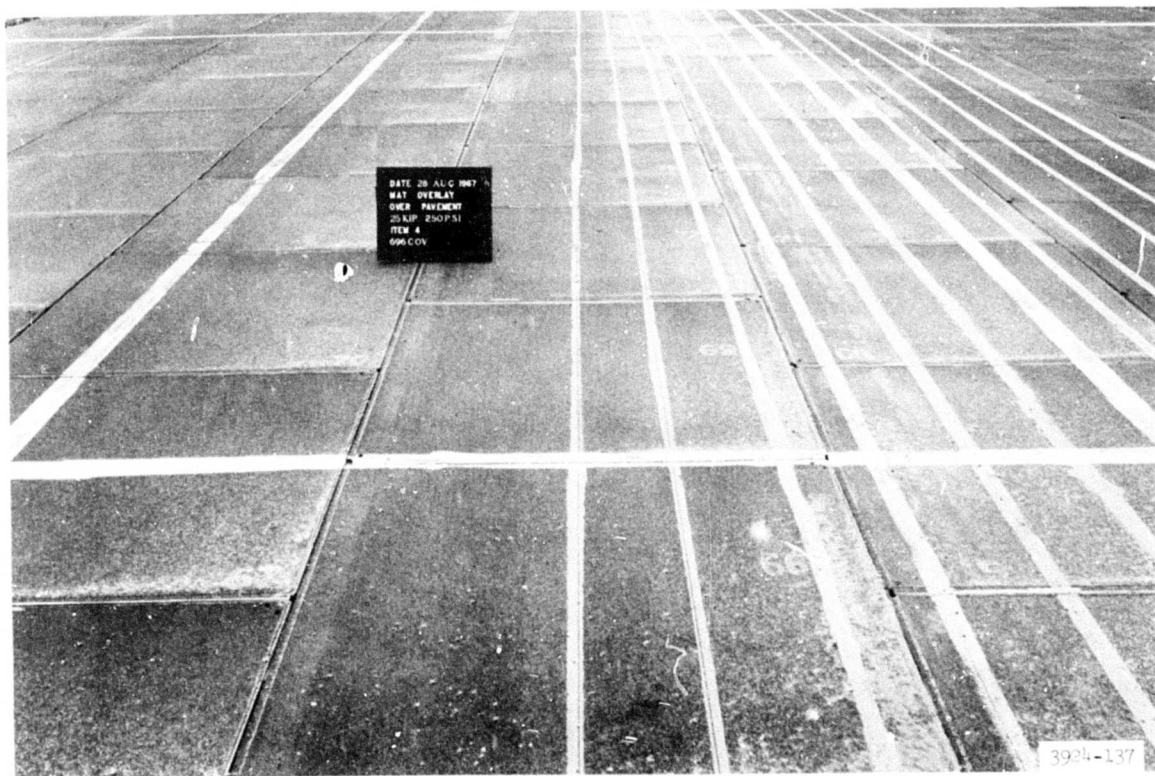
Photograph 40. Item 4 after 696 coverages

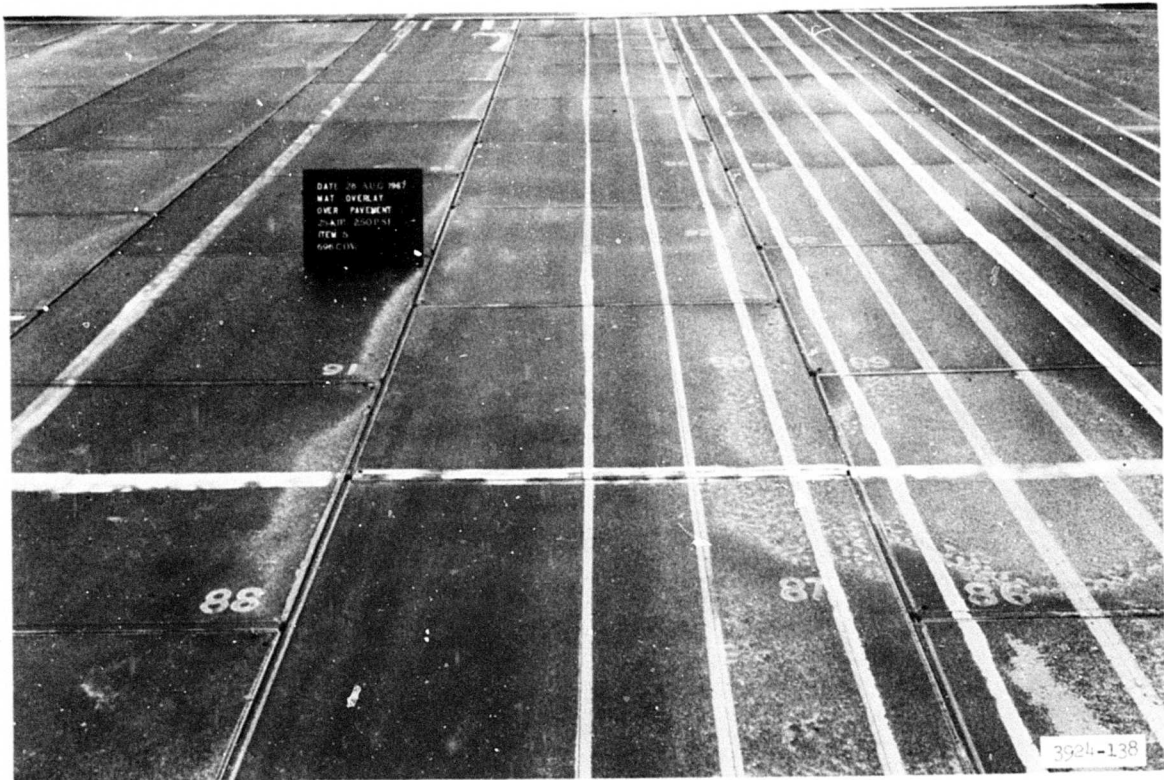
Photograph 41. Item 5 after 696 coverages

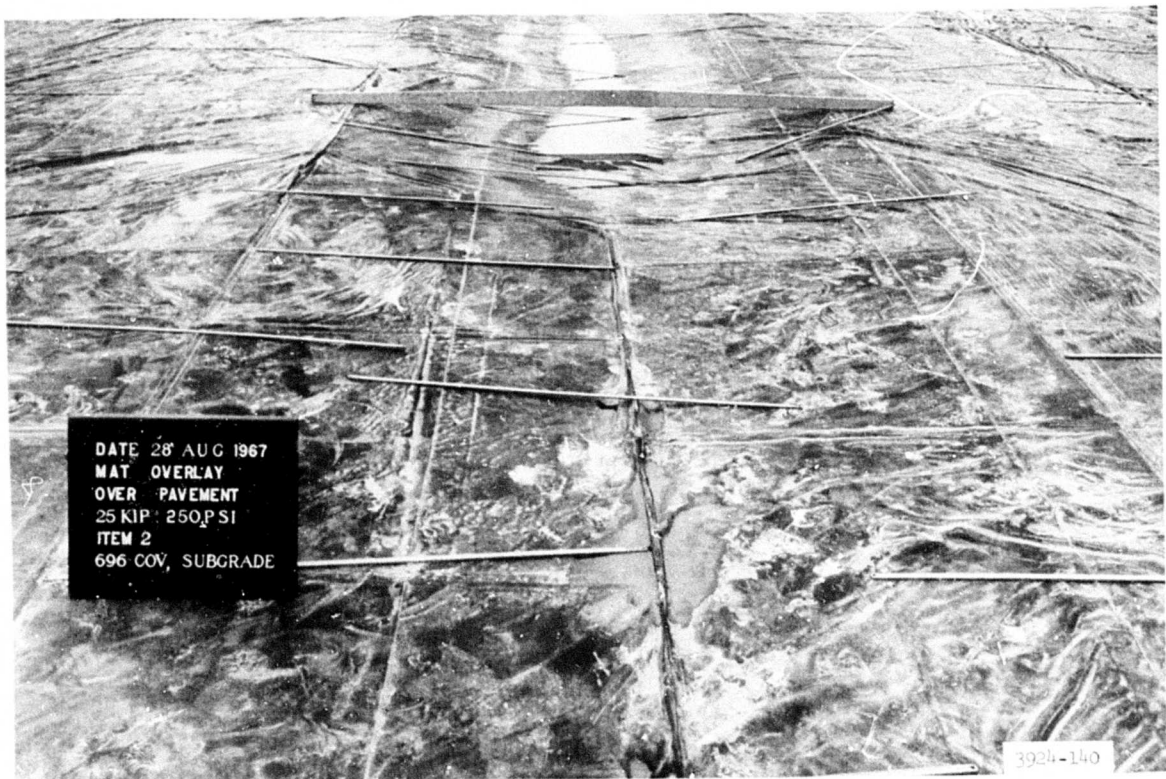
40. All mat was removed from the test section. A view of the membrane in item 2 after removal of the mat is shown in photograph 42. A view of the sand overlay in item 1 after removal of the mat and membrane is shown in photograph 43. From these photographs it can be seen that the sand leveling course in item 1 was still quite serviceable but that there was a severe depression in item 2. The sand in both items was quite wet from seepage under the TL6 membrane. This indicates that the 2- by 12-ft XML8 mat planks provide better confinement over a saturated sand than the 4- by 4-ft XML9 panels. Photograph 44 shows a view of the TL6 membrane before its removal from item 3. It can be seen from this photograph that numerous holes had been worn in the membrane as a result of the abrasive action of the mat on the clay gravel. The exposed clay gravel in item 4 is shown in photograph 45, indicating that the soil was still quite stable. Photograph 46 shows the depressed area that developed in item 5 during trafficking; note the free water ponded on the membrane. The compacted lean clay directly below the ponded water was relatively soft, indicating leakage through the membrane or under the free end of the membrane. However, the soil in the remainder of item 5 was quite dry and hard. Since, as shown in photograph 46, the clay gravel near the transition indicated signs of having been washed, i.e. the fines having been flushed out during trafficking, it was decided that the water had entered under the free edge of the membrane.

Photograph 42. T16 membrane in item 2 after mat was removed after 696 coverages (rods are XM19 connector bars)

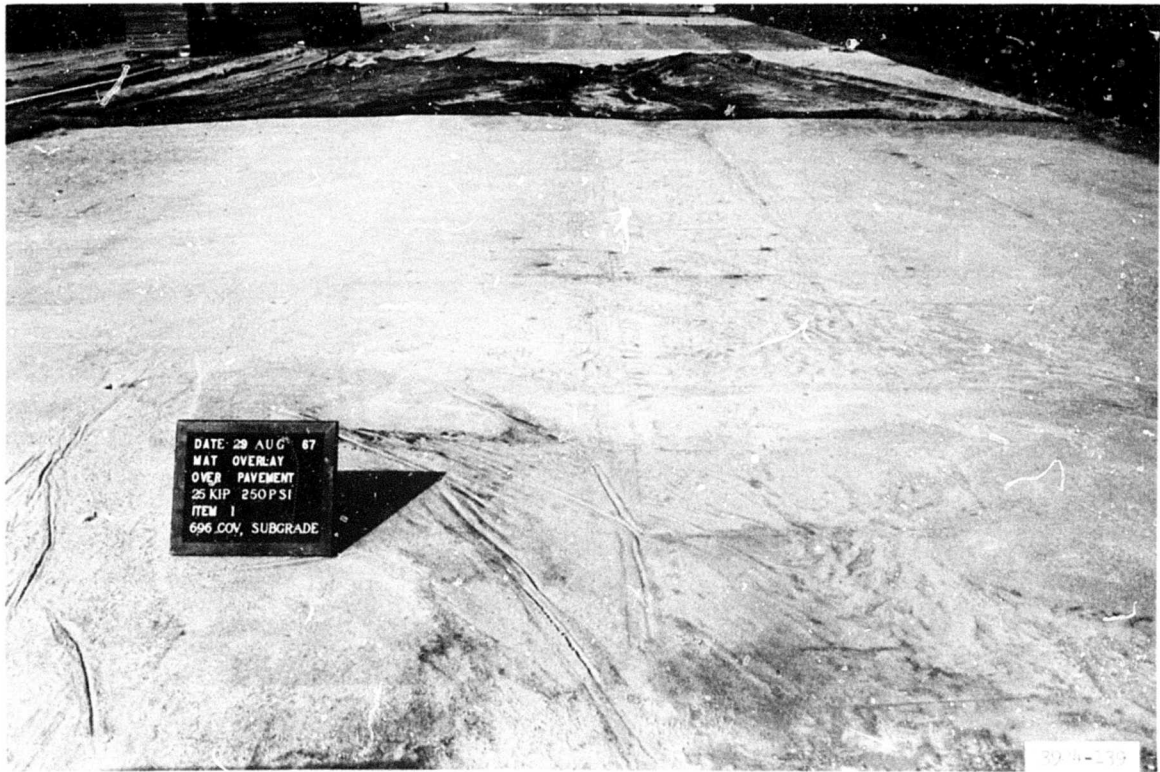
Photograph 43. Condition of sand overlay in item 1 after 696 coverages

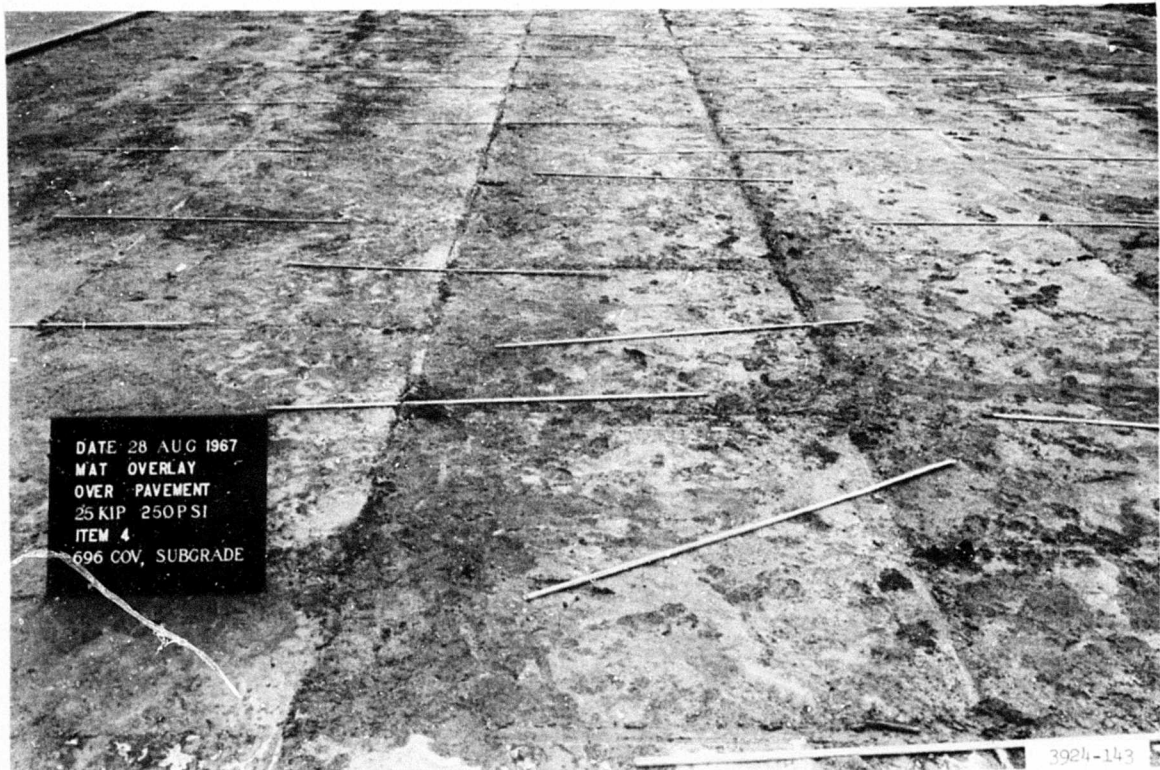
Photograph 45. Condition of clay gravel overlay after stabilization and subsequent 366 coverages (696 total coverages on section)

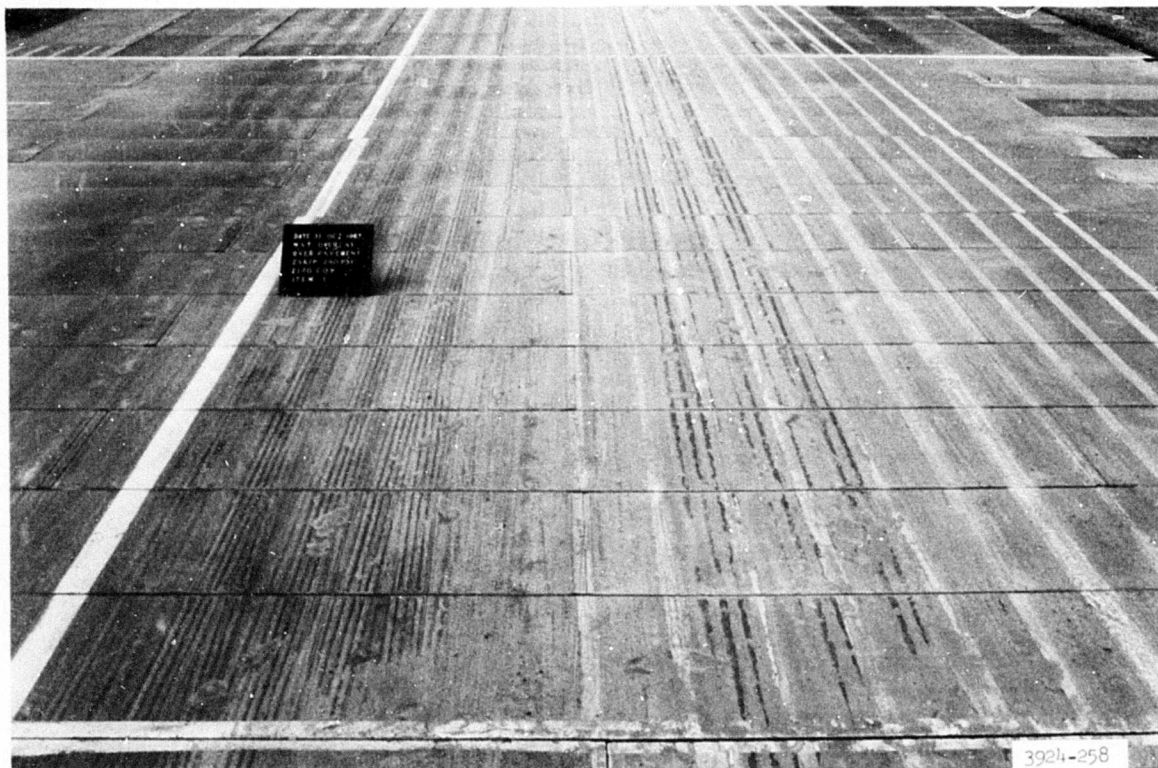
Photograph 52. Item 1 after 2170 coverages

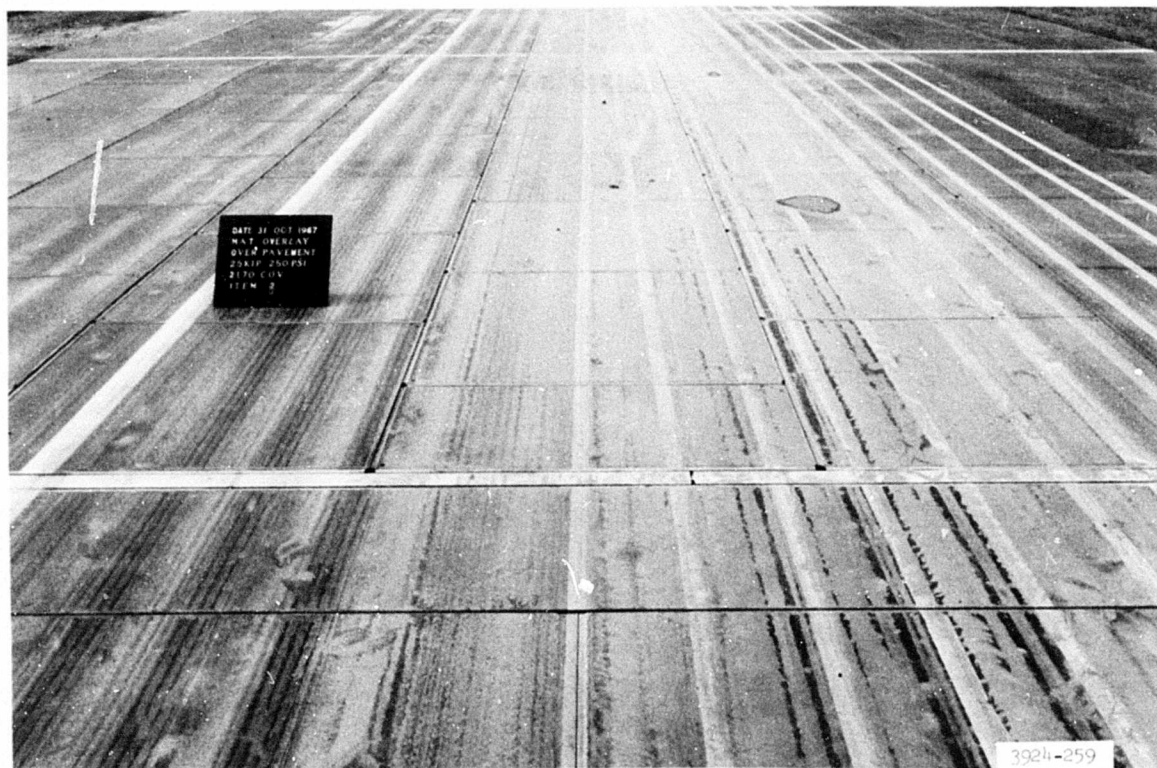
Photograph 53. Item 2 after 2170 coverages

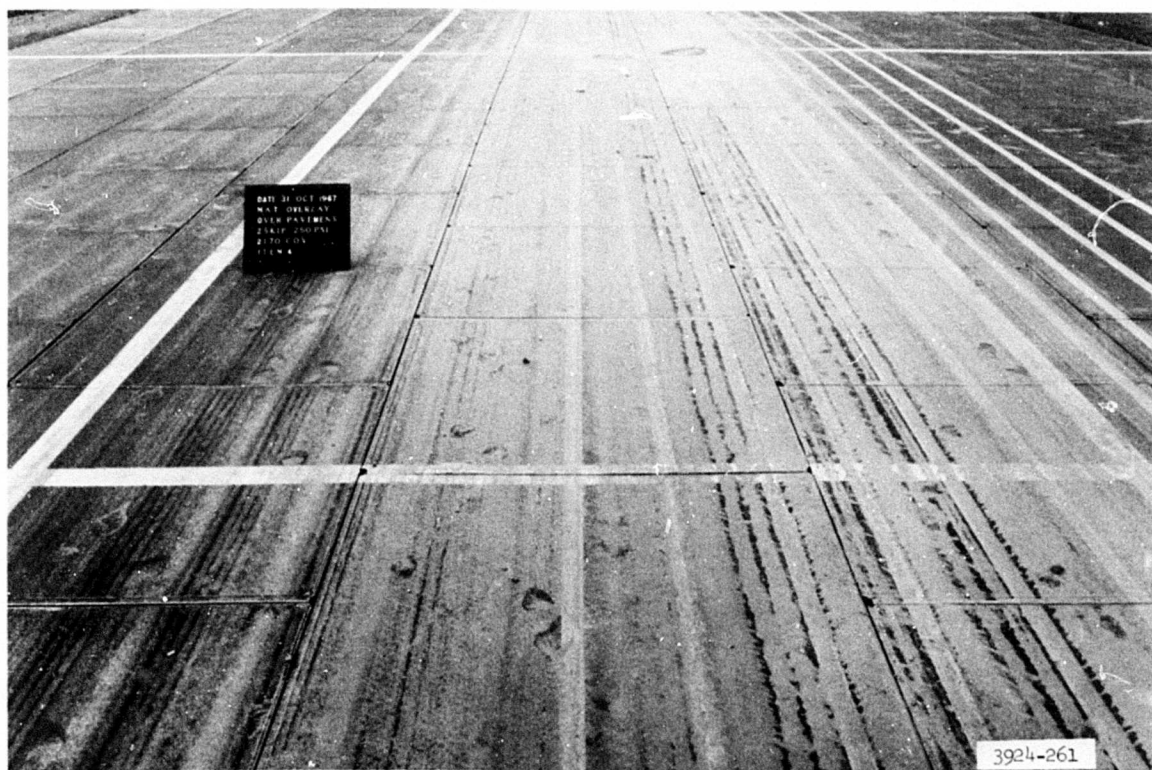
Photograph 55. Item 4 after 2170 coverages

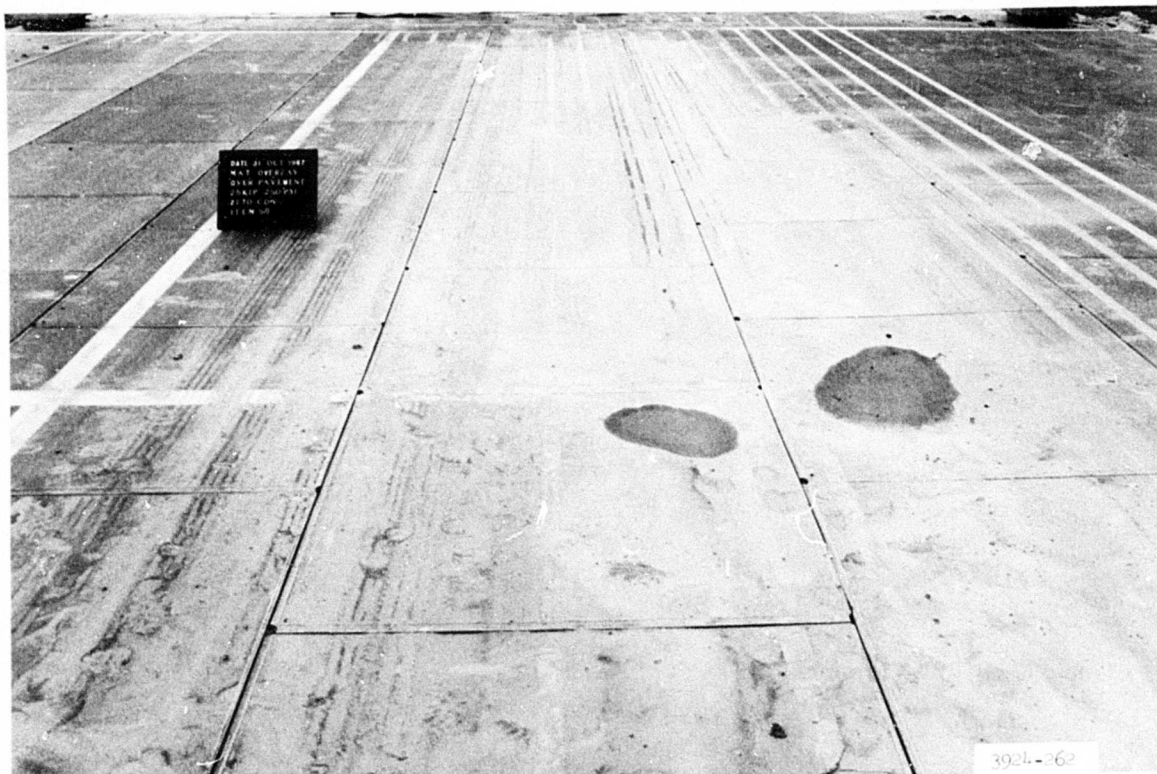
Photograph 56. Item 5 after 2170 coverages

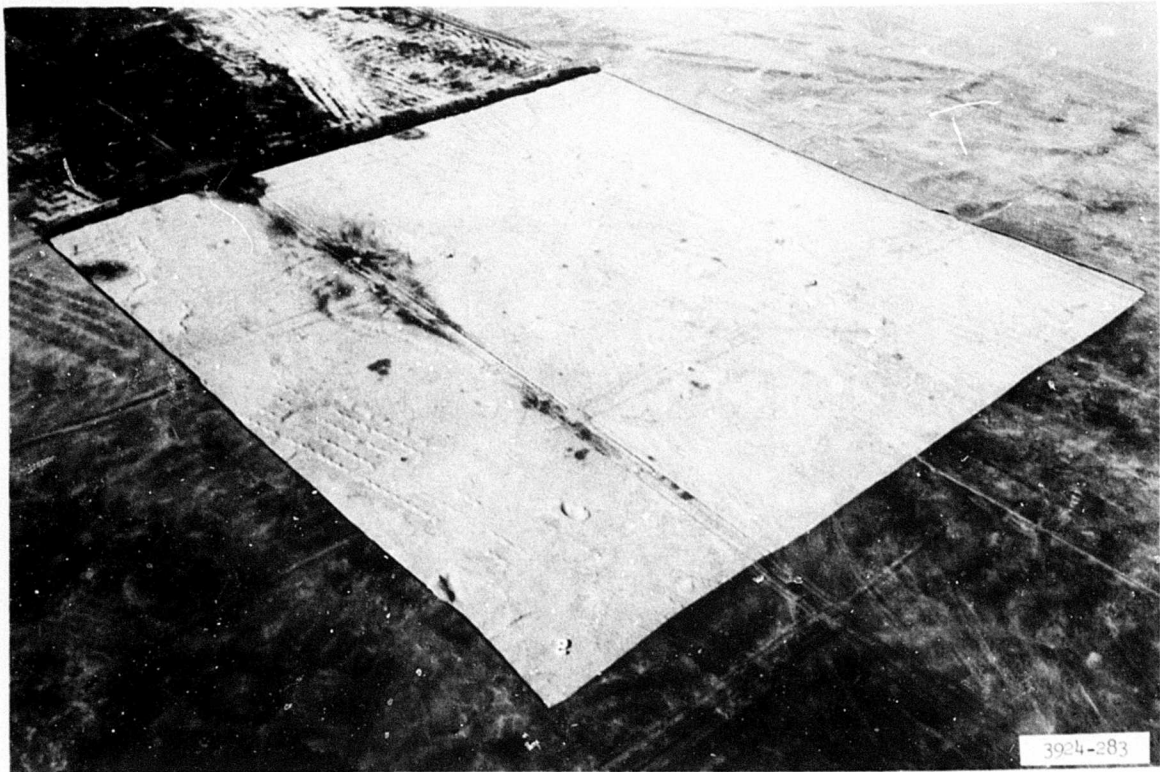
Photograph 60. Condition of sand in item 2 after 2170 coverages

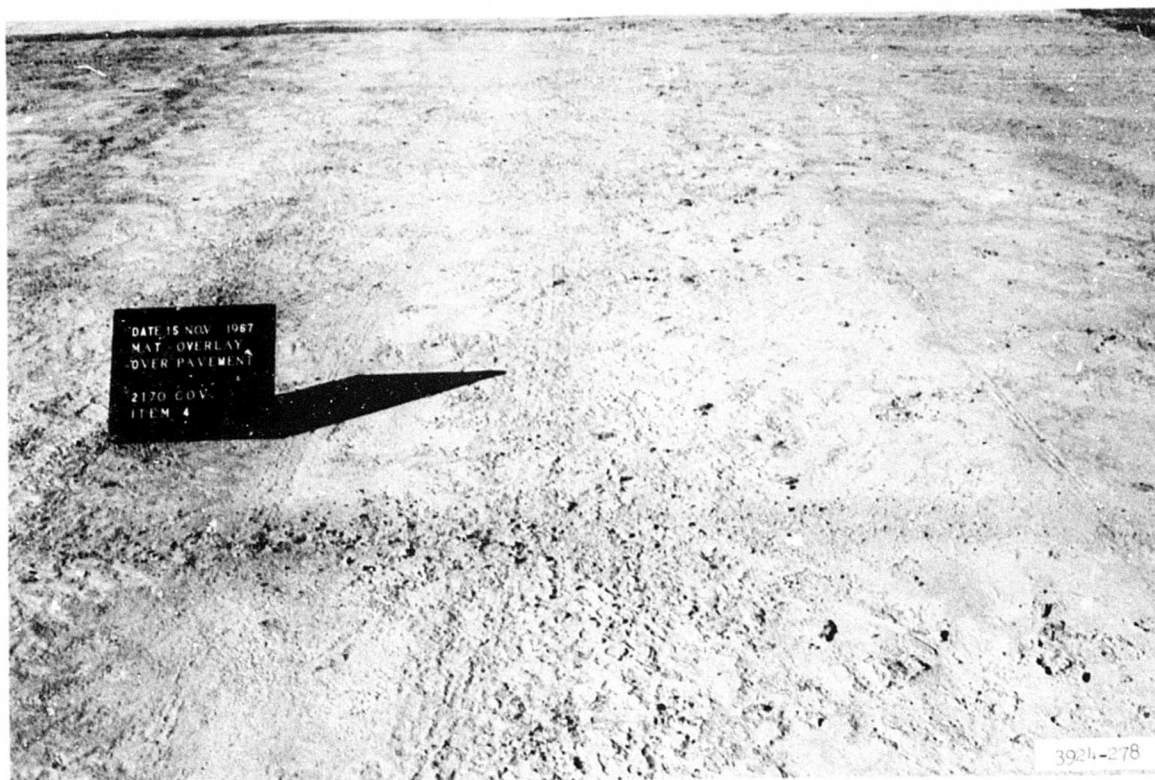
49. The clay gravel in item 4 that had been stabilized with portland cement is shown in photograph 62. The lower part of the photograph actually shows part of the clay gravel leveling course in item 3, which was also stabilized with portland cement. From this photograph, it can be seen that the stabilized clay gravel was still quite stable. Soil tests at this time indicated that the surface strength of the material in item 4 was in excess of 300 CBR.

Photograph 62. Condition of stabilized clay gravel in item 4 after 2170 coverages

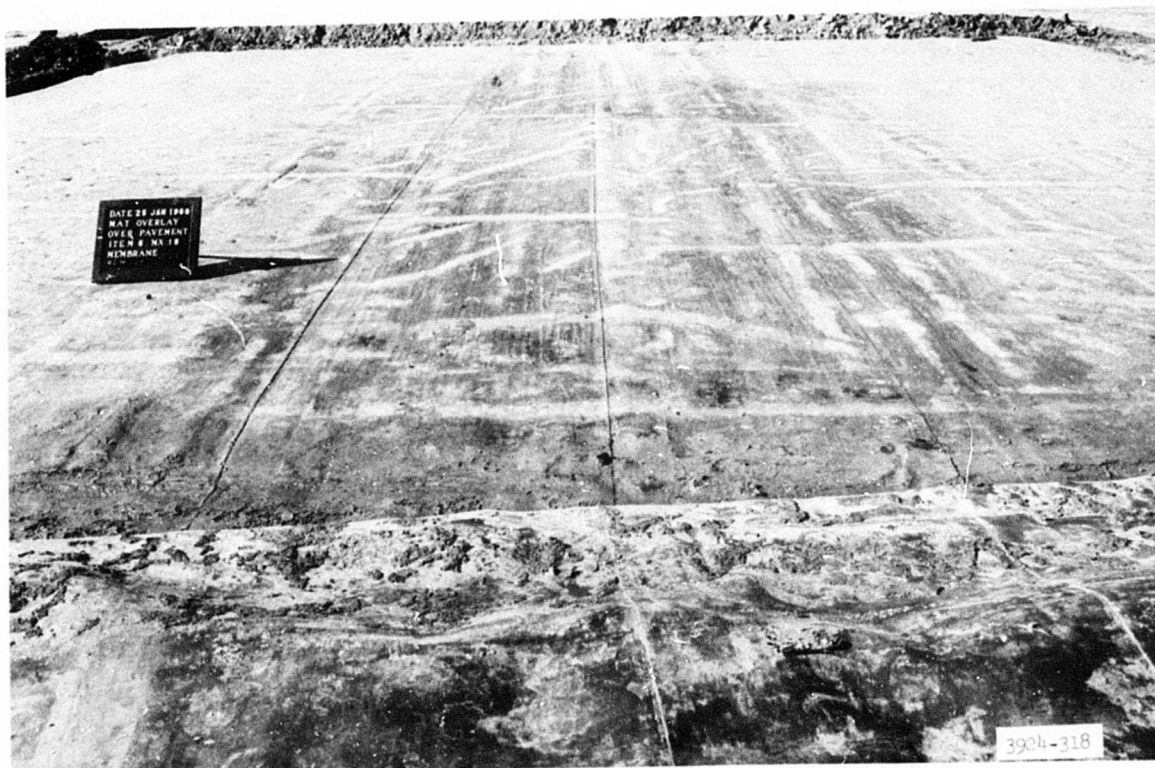
52. The WX18 membrane on item 6 was not removed until all test traffic had been completed, although traffic was stopped on item 6 at 510 coverages. A view of the exposed lean clay after removal of the membrane is shown in photograph 66. The soil was stable, and tests indicated the strength of the lean clay at the surface and 4 in. below the surface to be 94 and 85 CBR, respectively.

Photograph 66. Lean clay in item 6 after removal of membrane
